Waterproofing Treatment to the Swimming Pool Area @

Rasun Ace Infra Pvt Ltd

ELYSIAN

Ultra Luxury Apartments @ Kendor

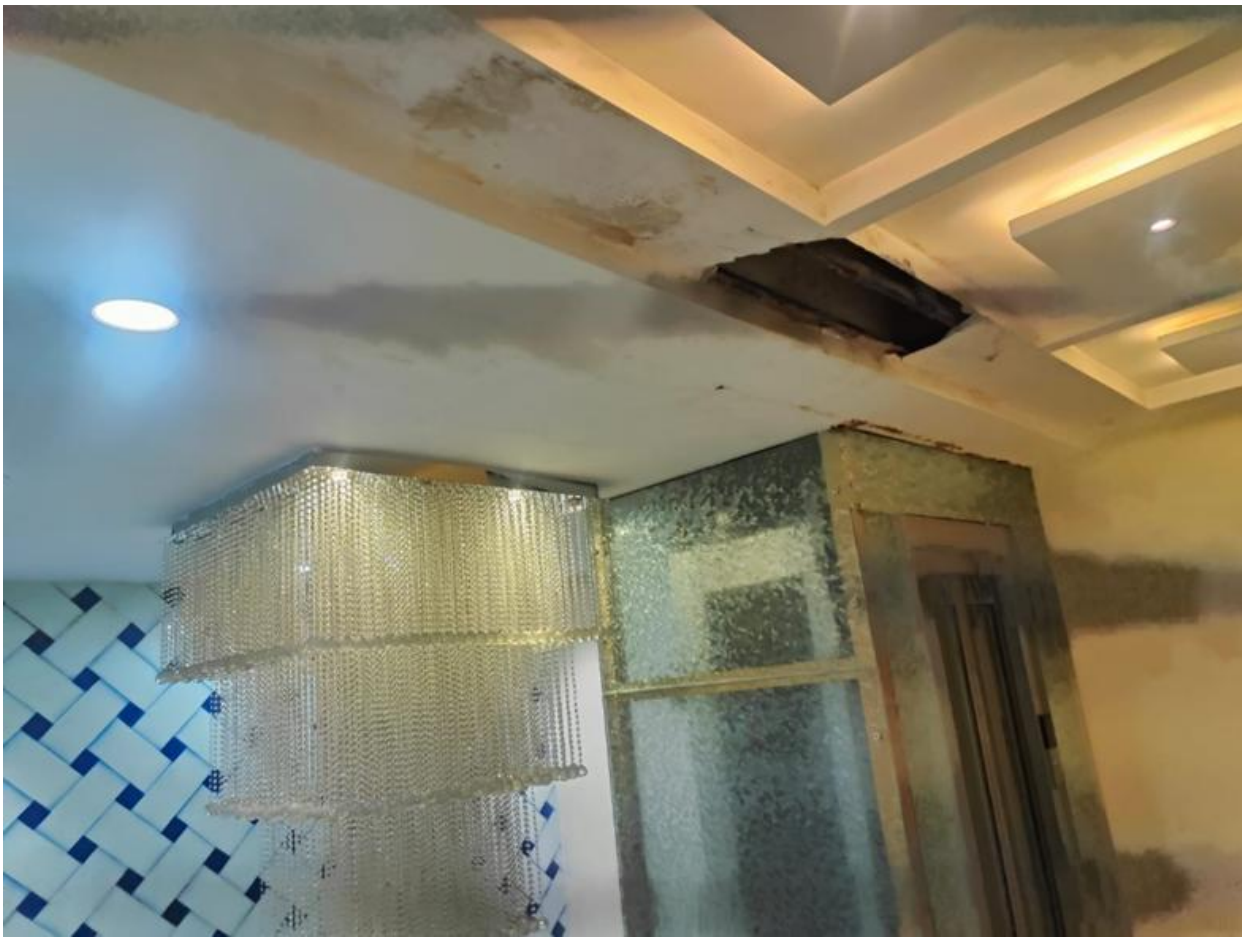
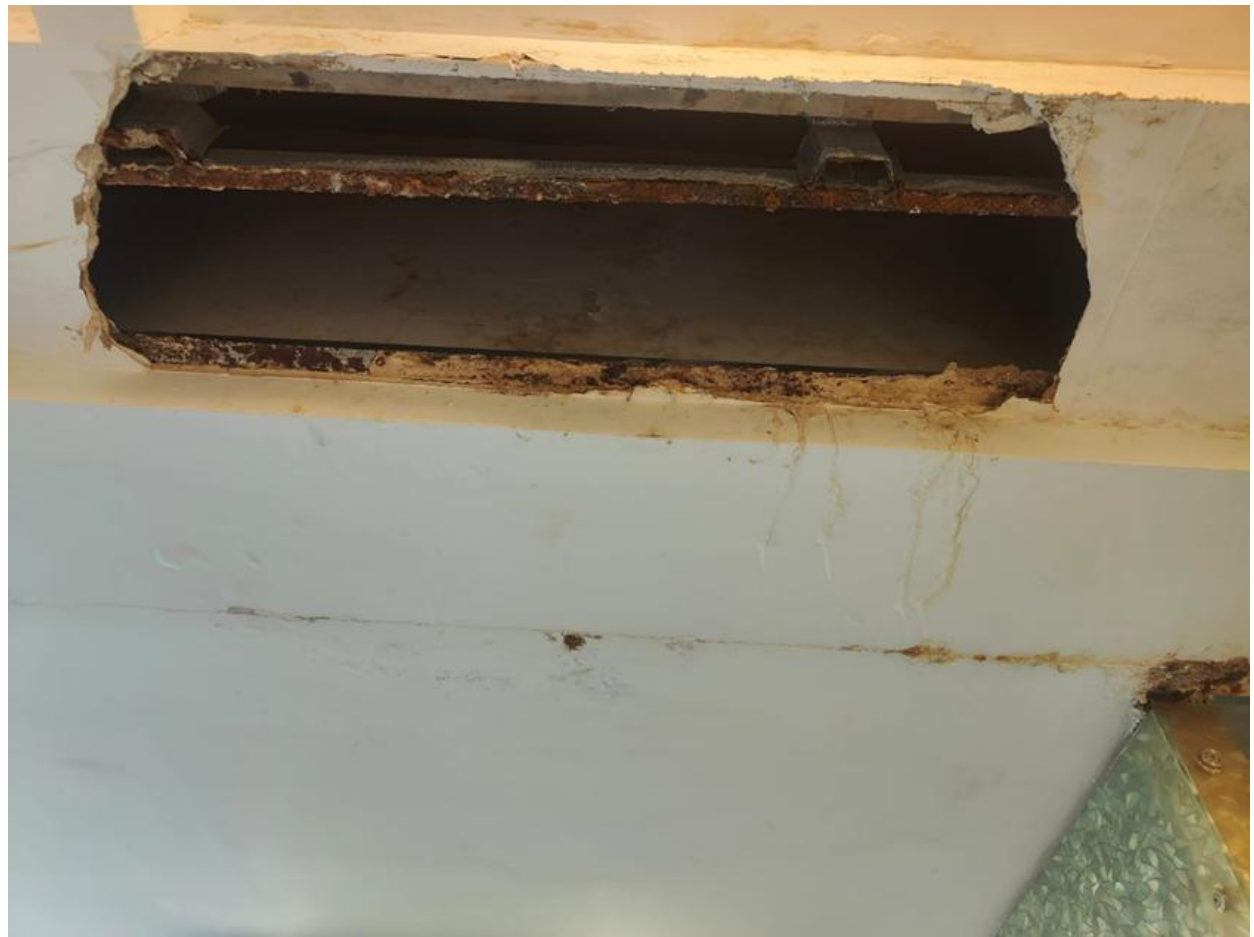
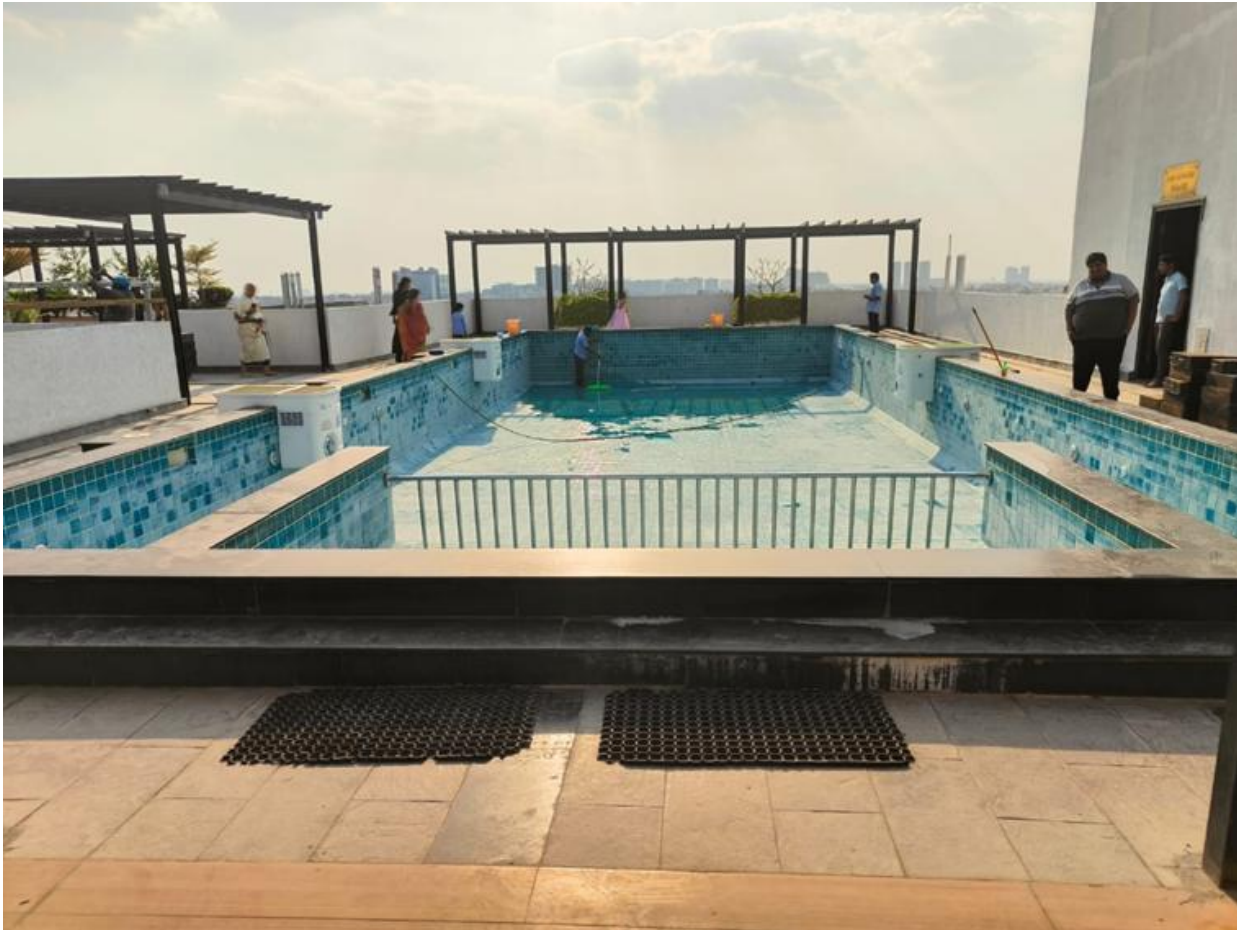
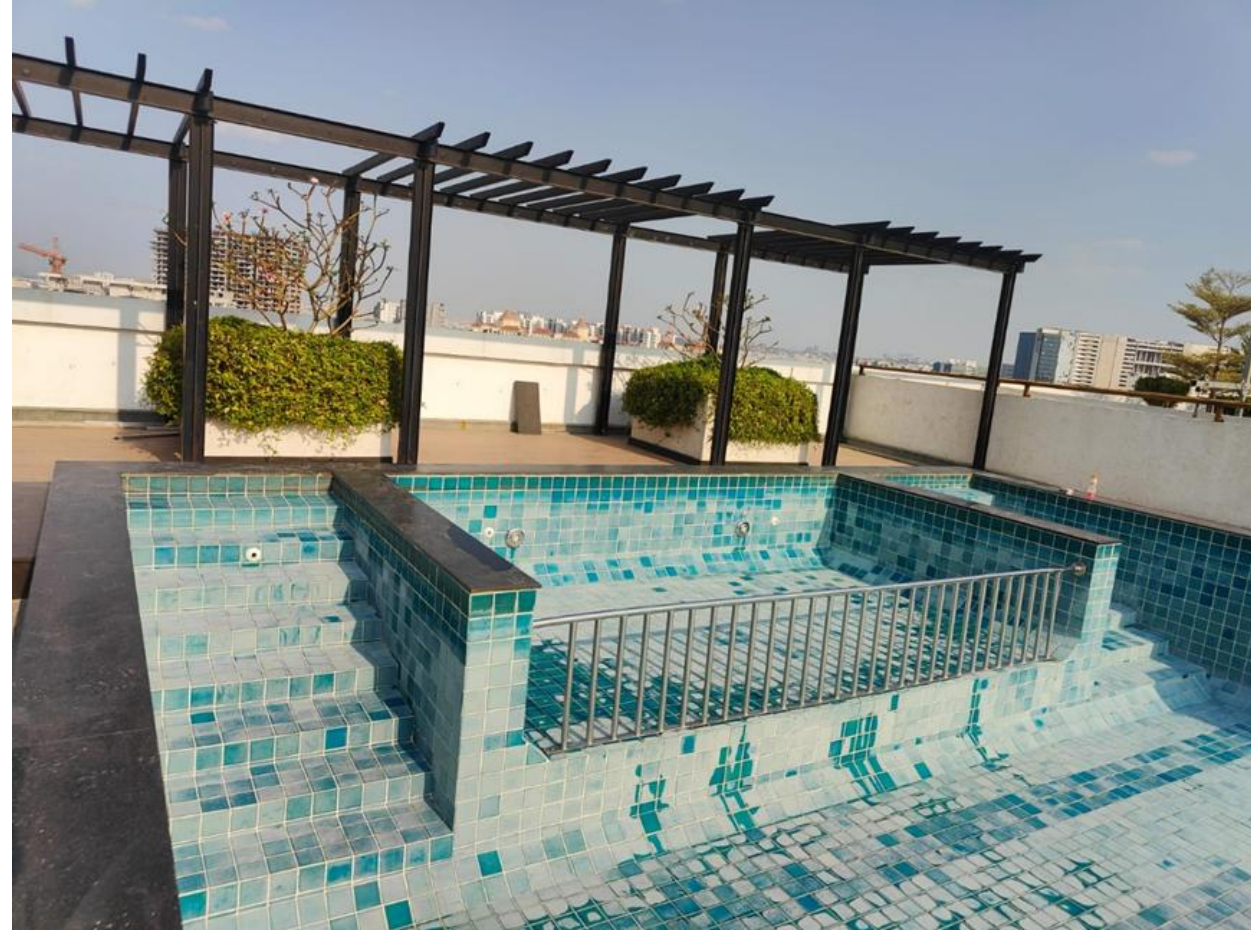
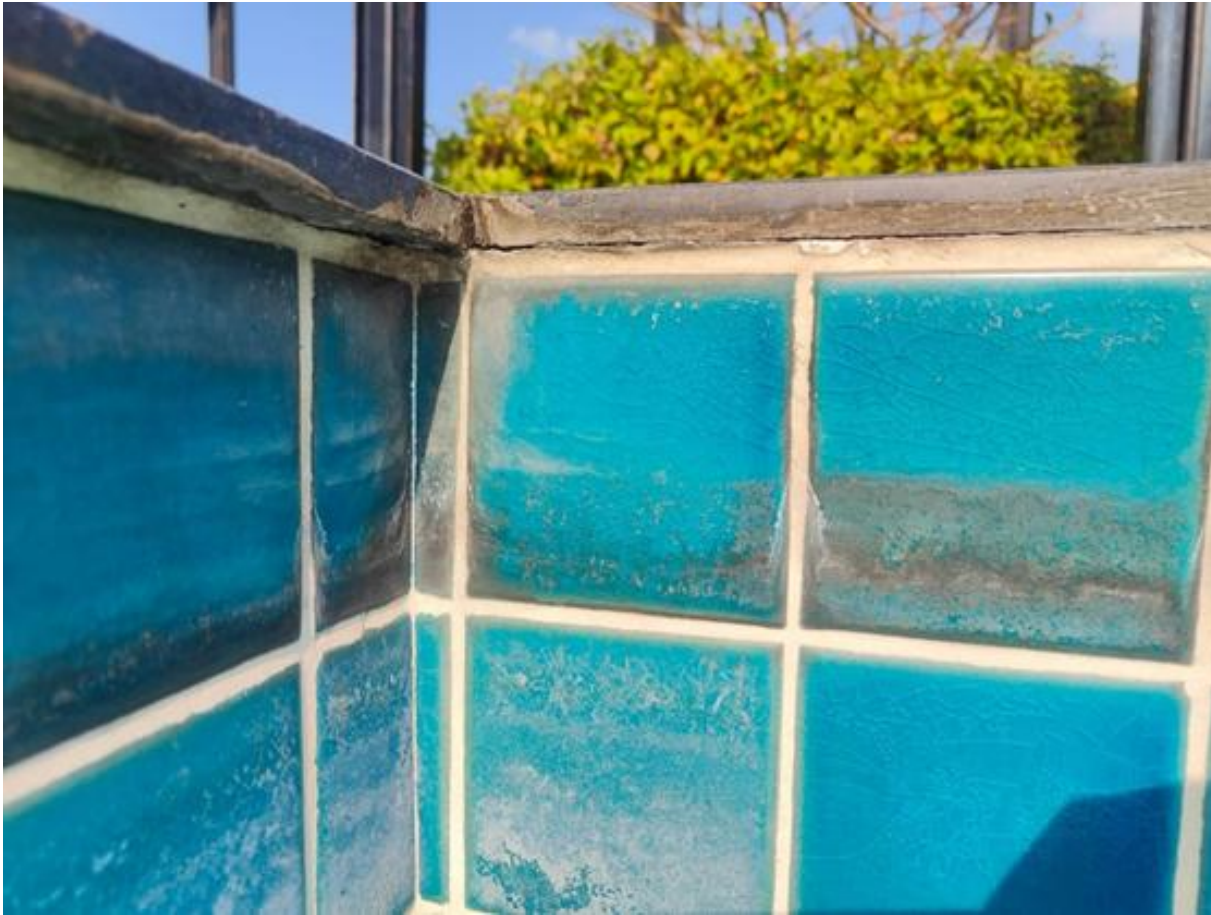
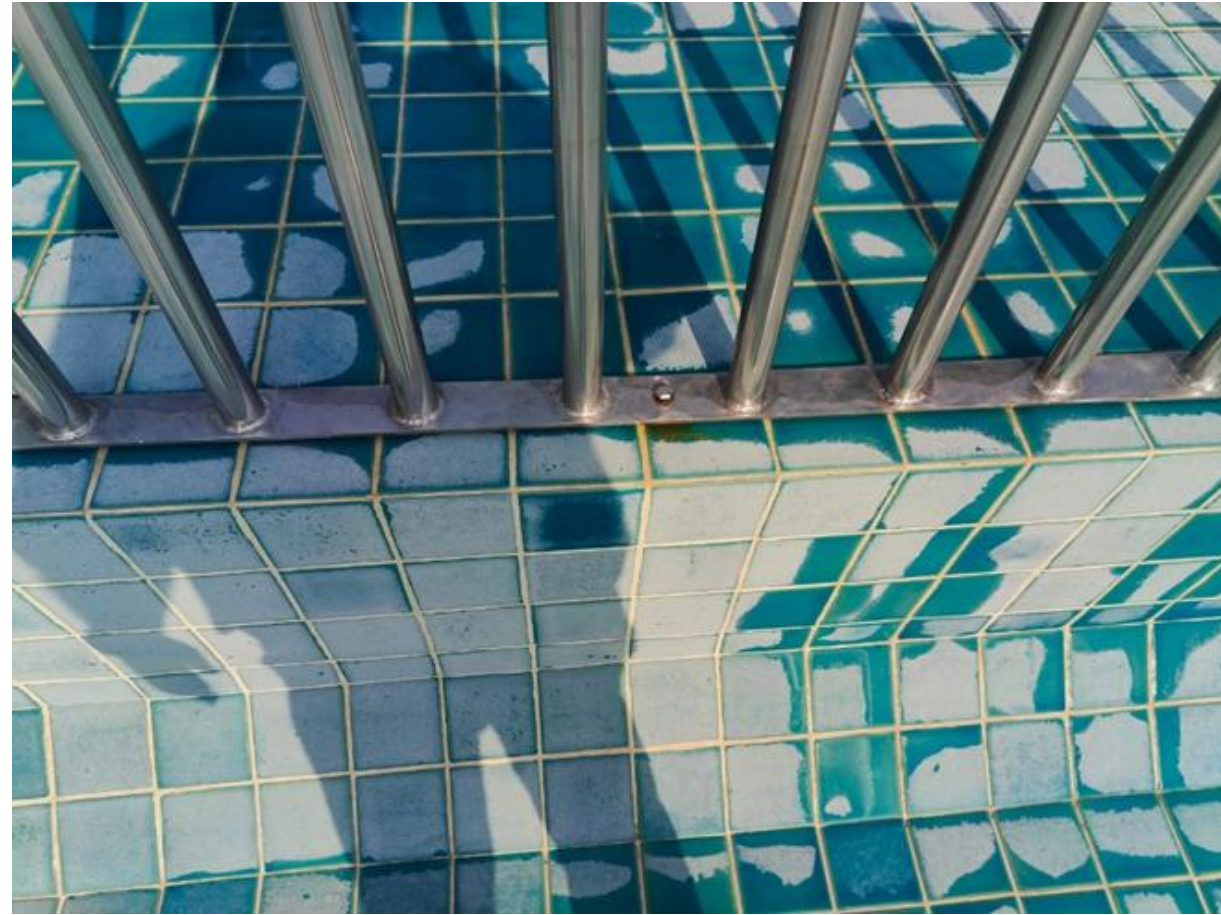
Observed Heavy Leakage form the Beam and Ceiling area of Flat No. SV 01. After Thoroughly Examine the above Pool area we have observed so many Tile Joints are opened and even most of the water accumulated under the Steps made with Aerocon bricks from long time and coming out below the Beam and Ceiling area.

- **Epoxy Tile Joint Treatment to the Inside Tile Joints, Above Granite Joints, Planter Skirting Joints and Pool Periphery Granite Joint Area**
- **Chipping the Existing Steps and carting away the debris.**
- **Polyurethane Injection Grouting to the Slab Area and below Beam area (Positive/Negative side)**
- **Polyurethane Coating to the Chipped Steps area and water ponding Test for three Days.**
- **Application of Ties with MYK Tile Adhesive, then Grouted with Epoxy Grout Myk Laticrete SP-100.**
- **Installation of Steel Ladder.**

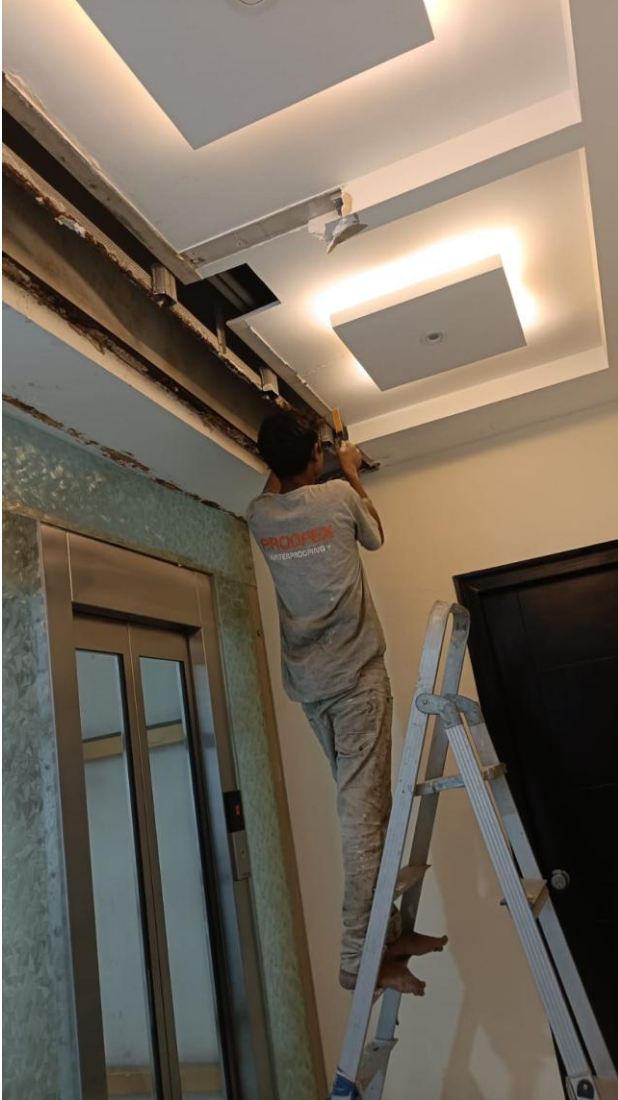
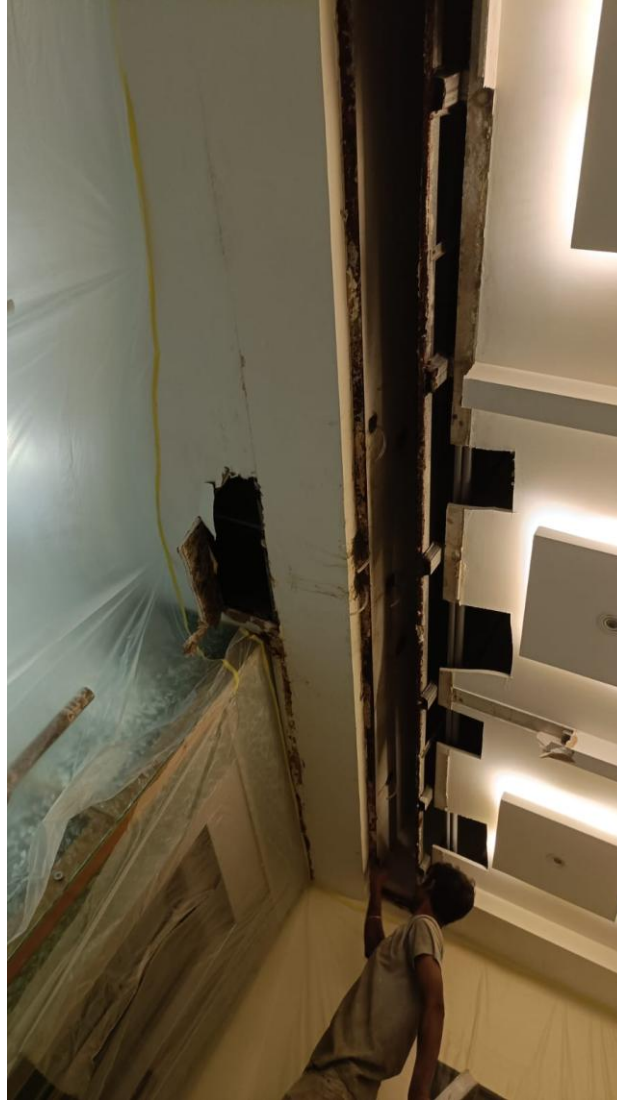
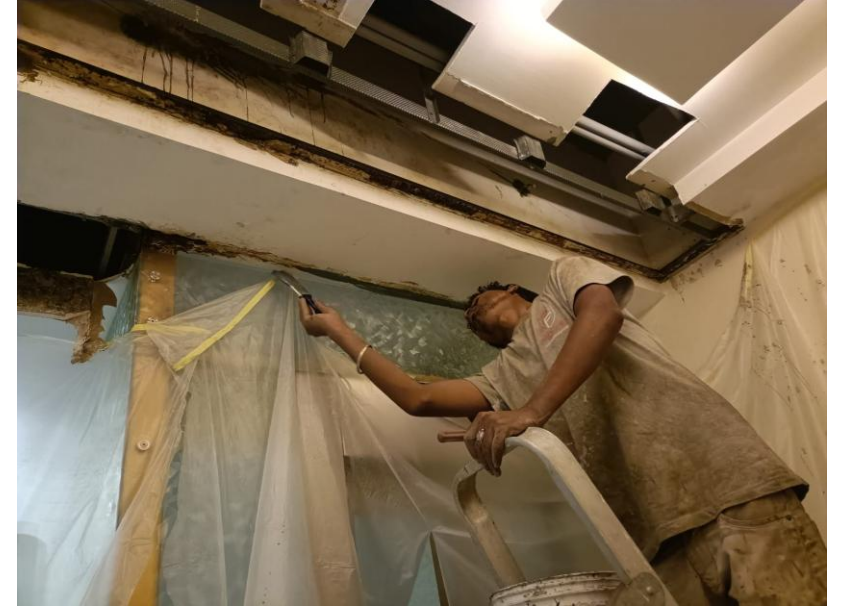
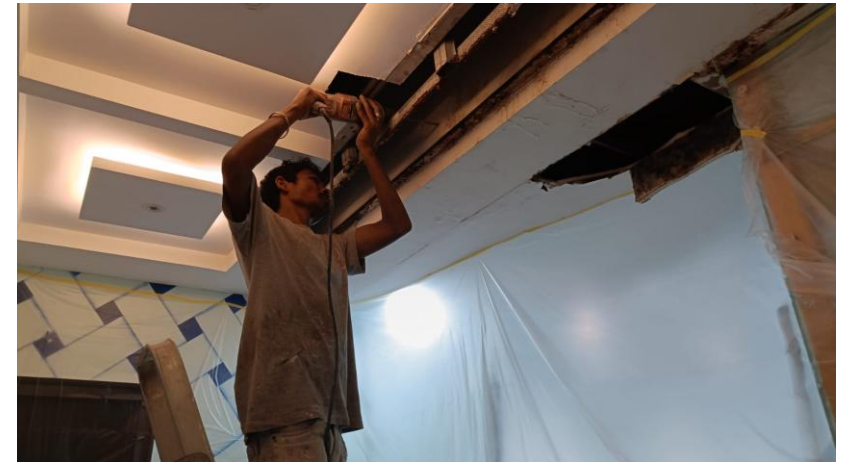
Removing the Affected False Ceiling, Anti Corrosive Treatment to the corroded Iron area and Injection Grouting

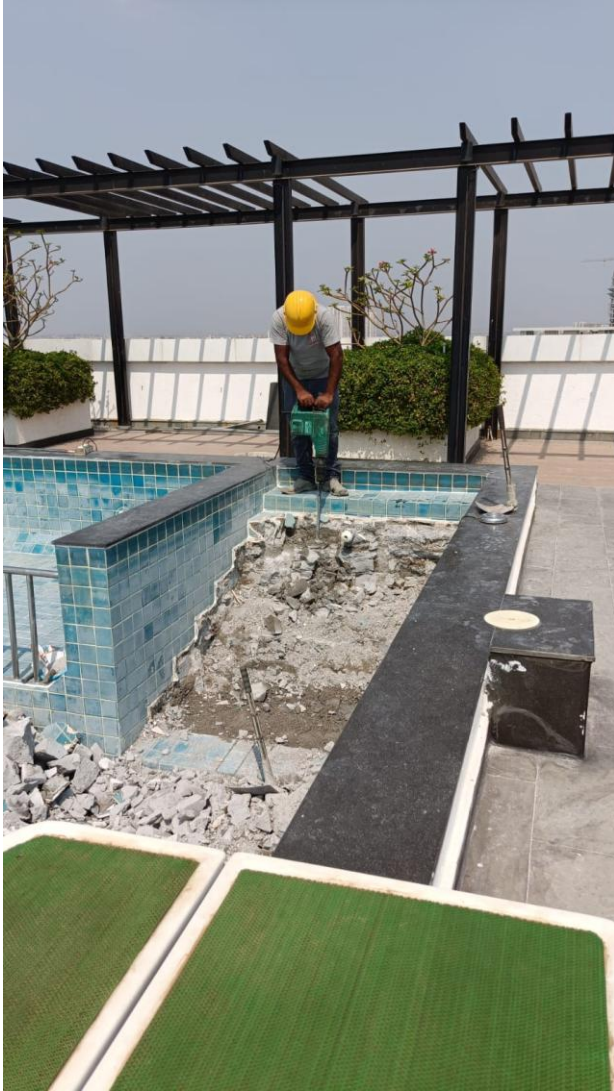
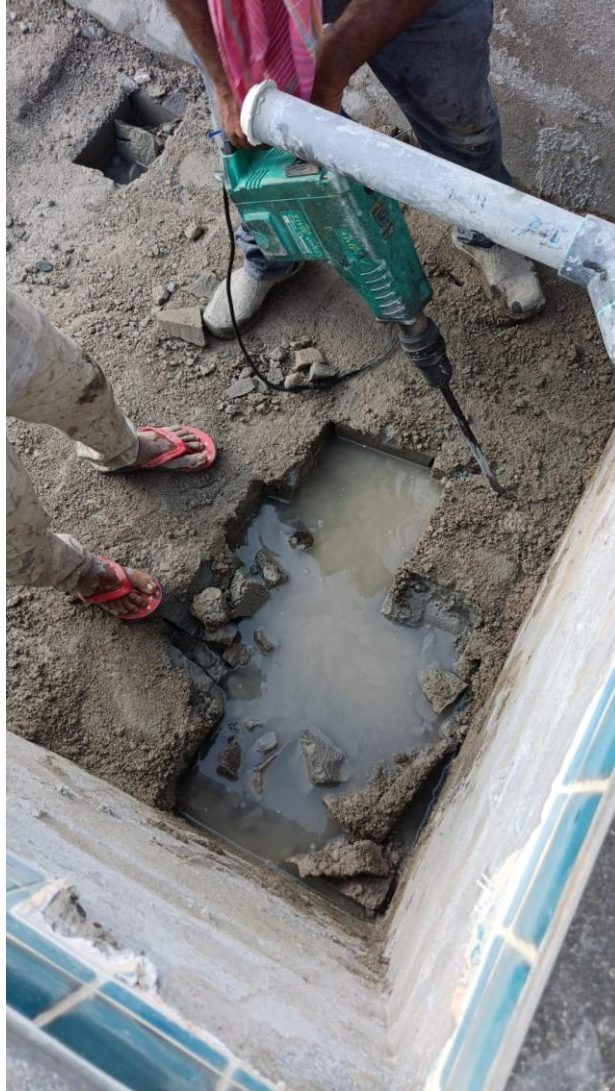
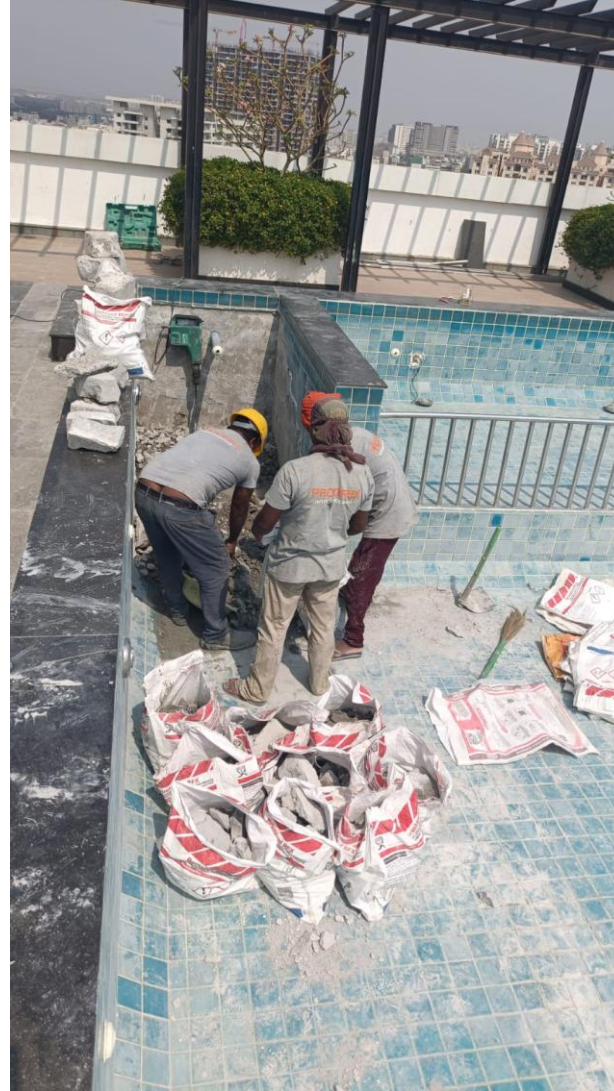
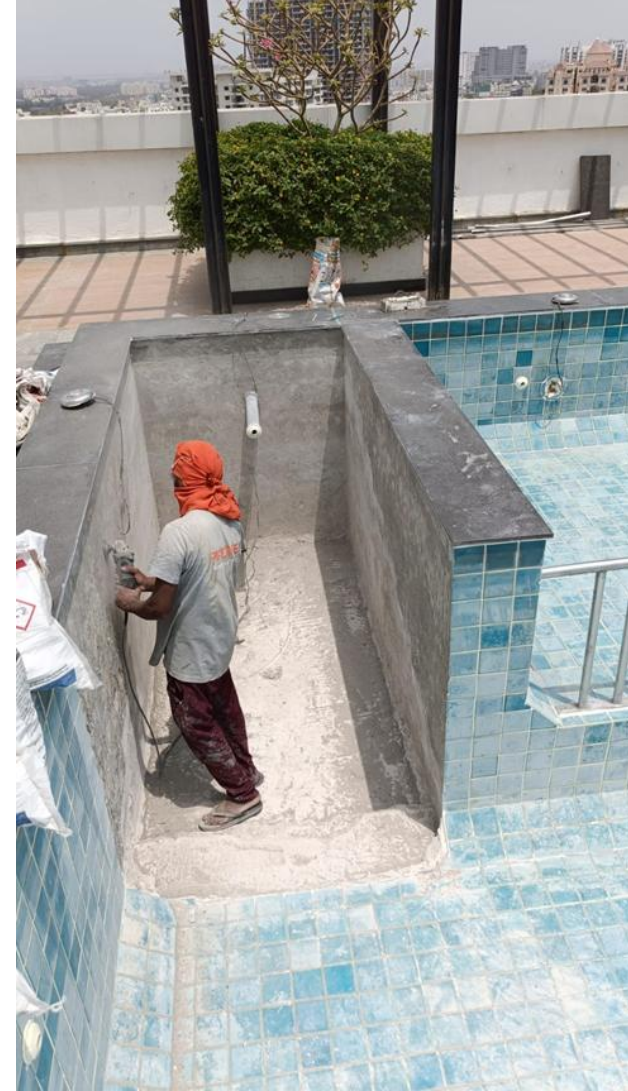
Dismantling the Existing Aerocon Steps area , carting and buffing the surface

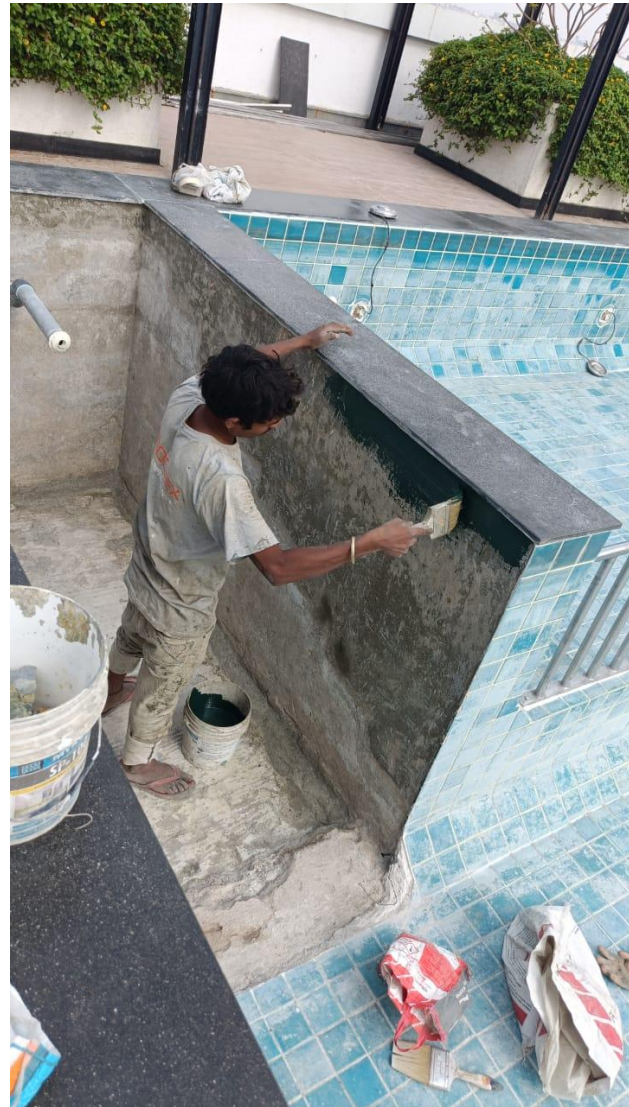
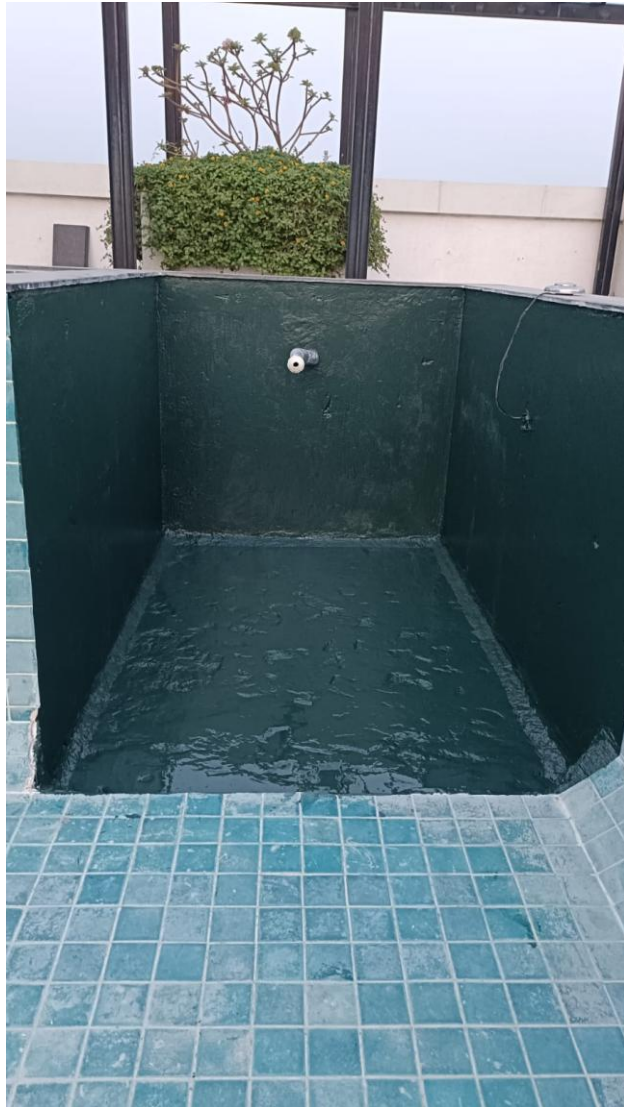
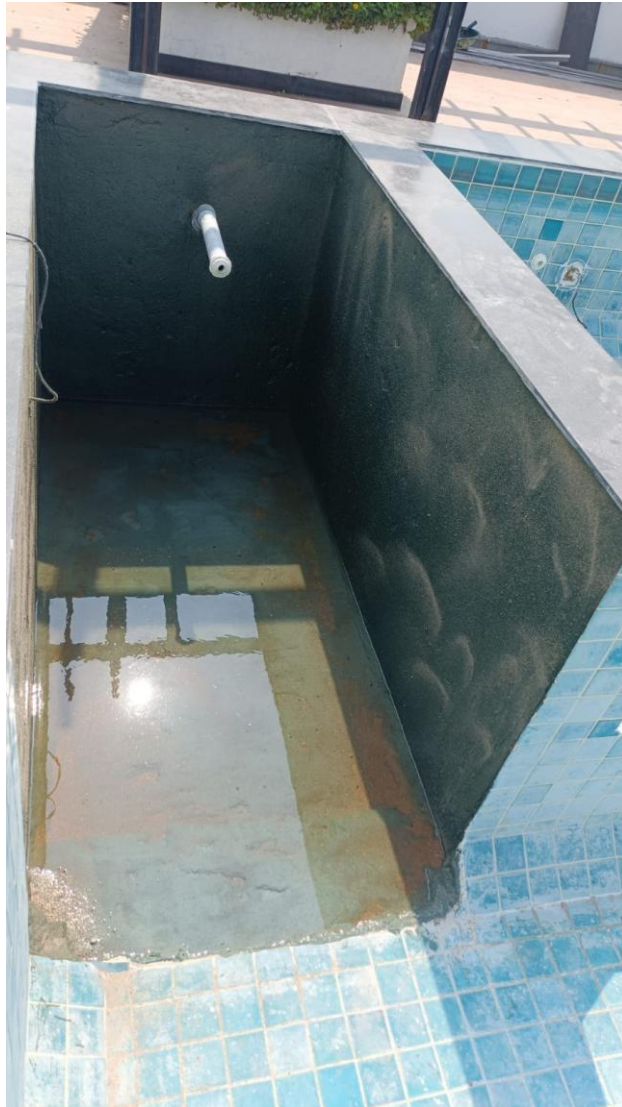
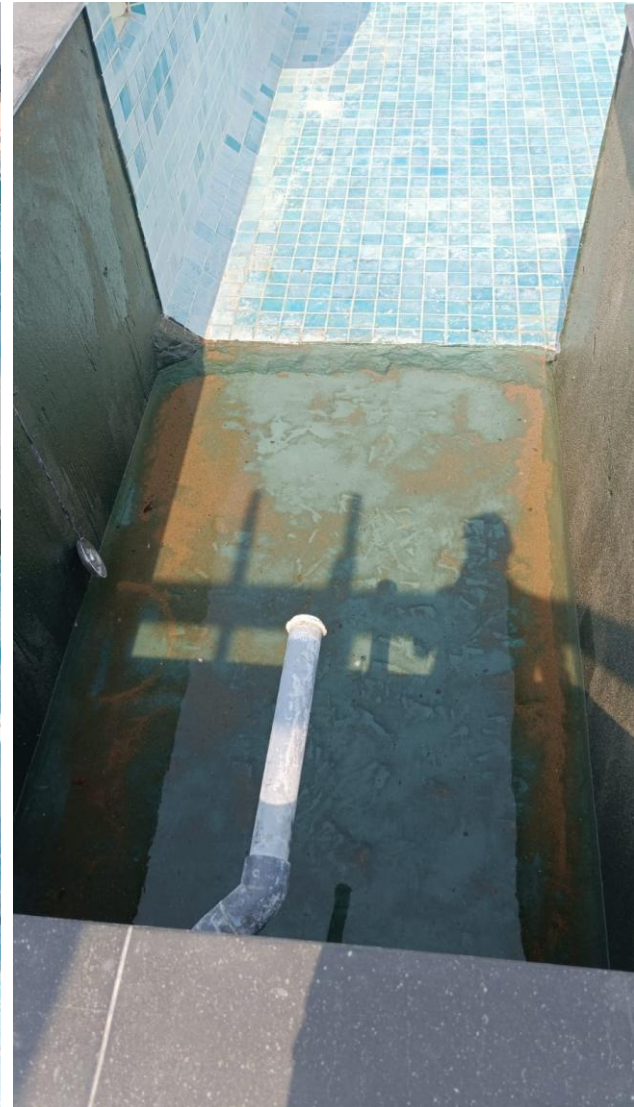
PU Grouting, Coving and Polyurethane Coating and Pond Test

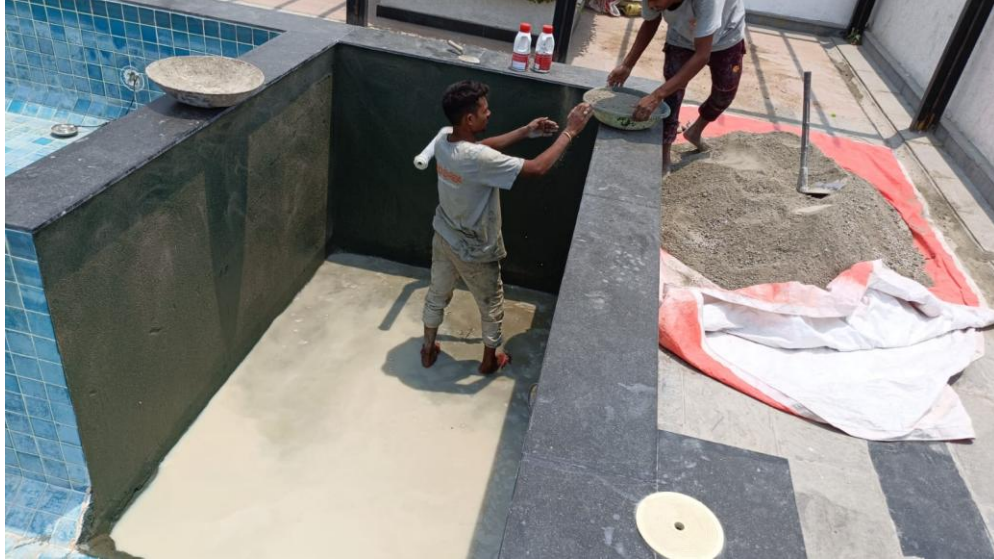
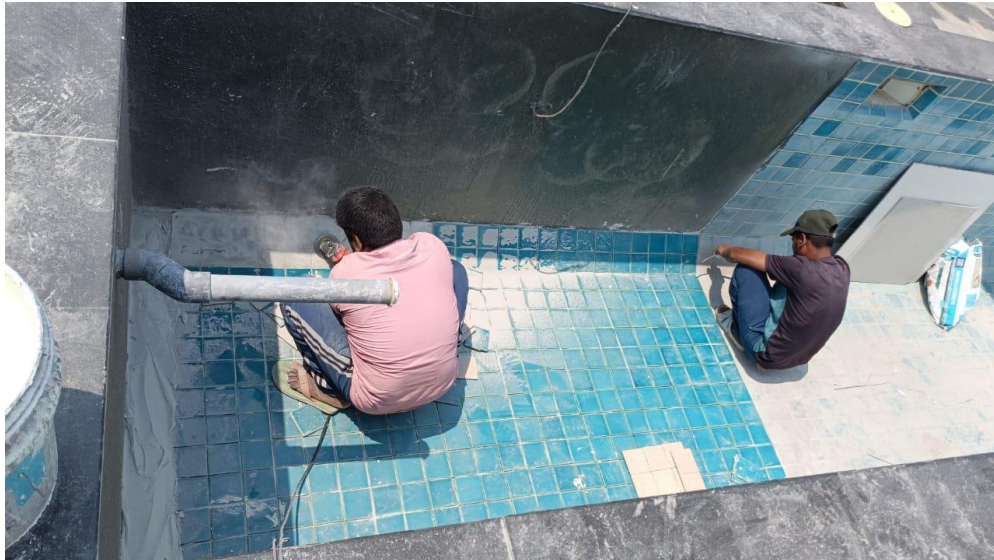
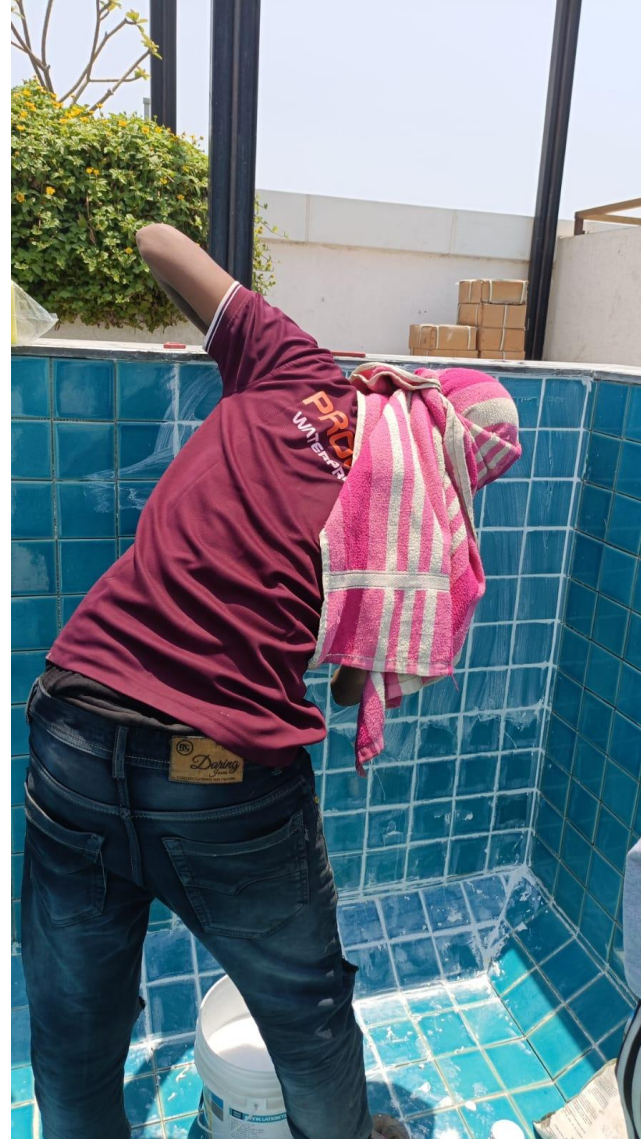
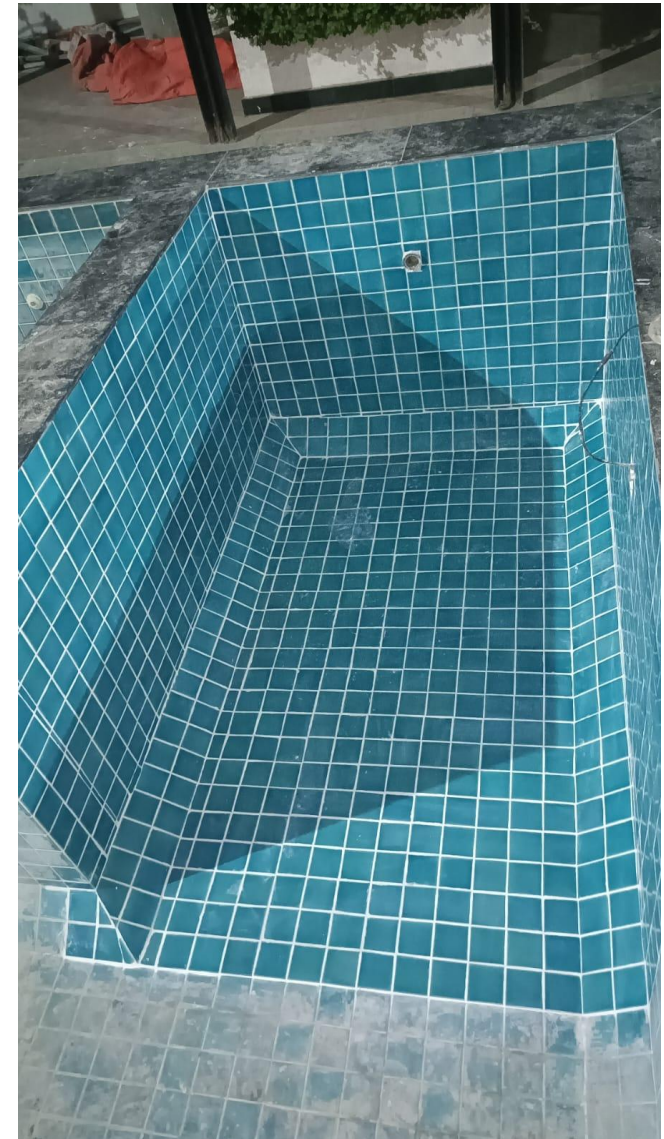
Hydrophobic Cement Mortar Treatment to the Mother Slab area, Application of Tiles and Grouted with Epoxy Grout to the Tile Joints.

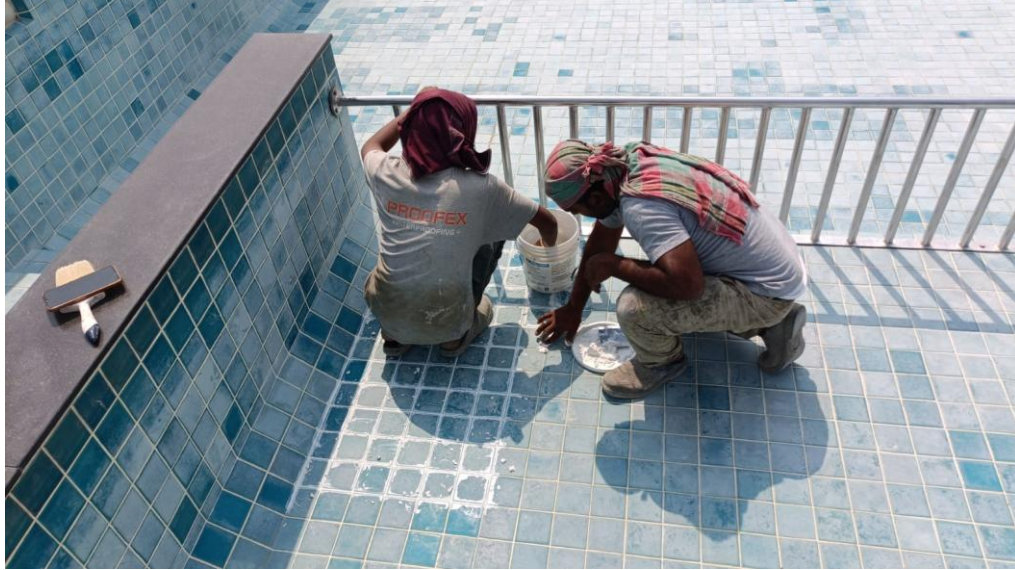
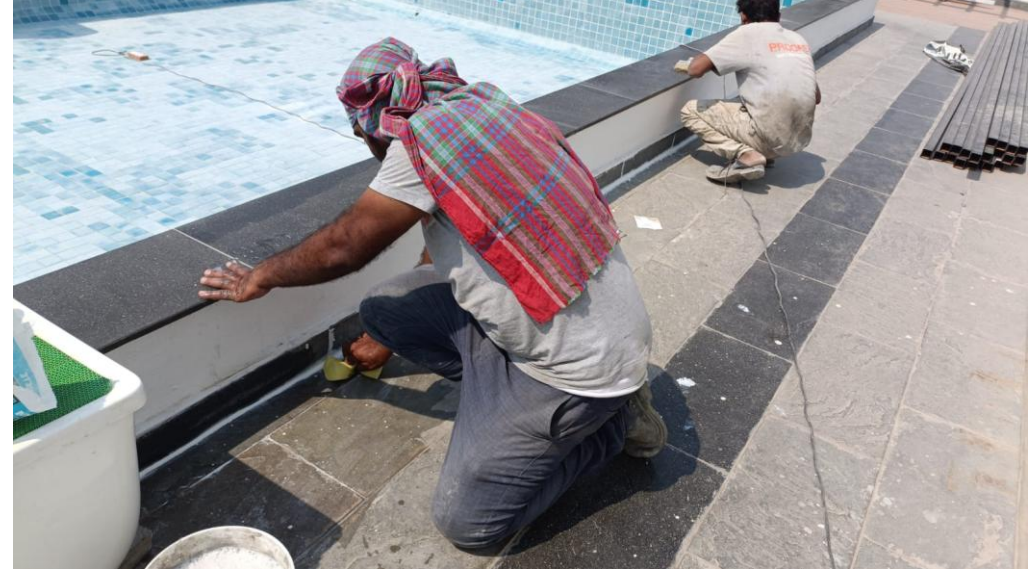
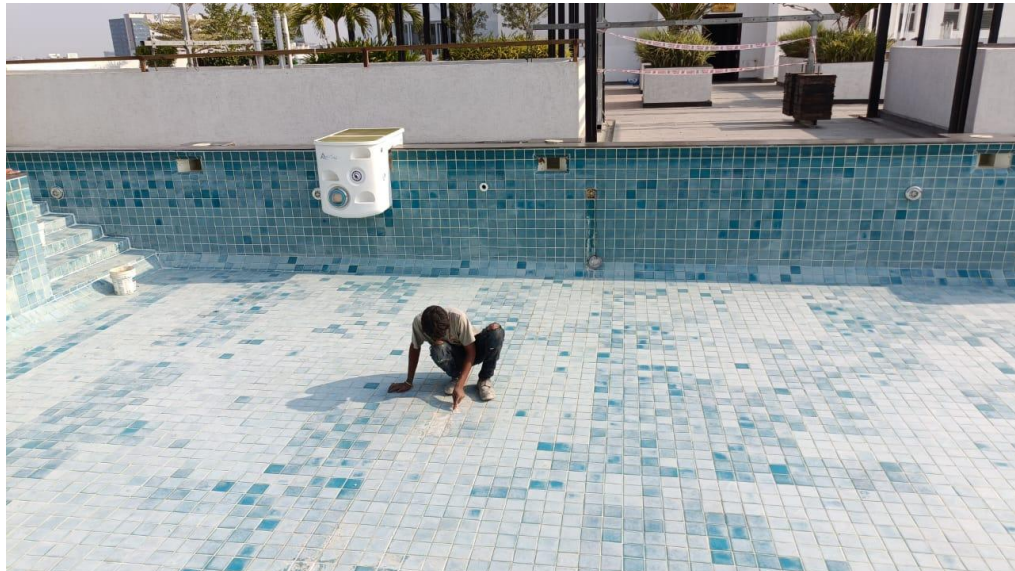
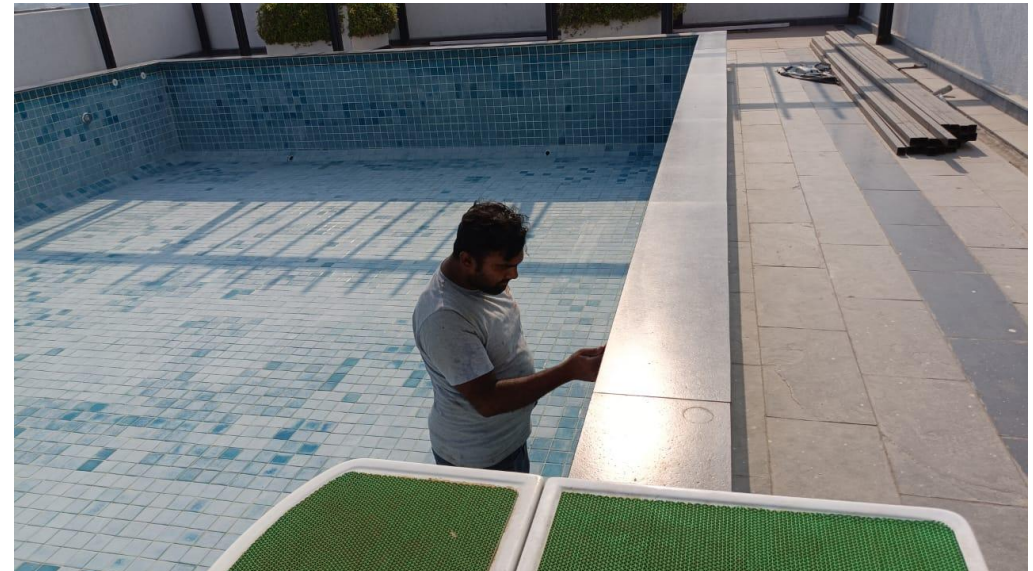
Epoxy Tile Joint treatment to the inside tiles ad Periphery Granite Joint area.

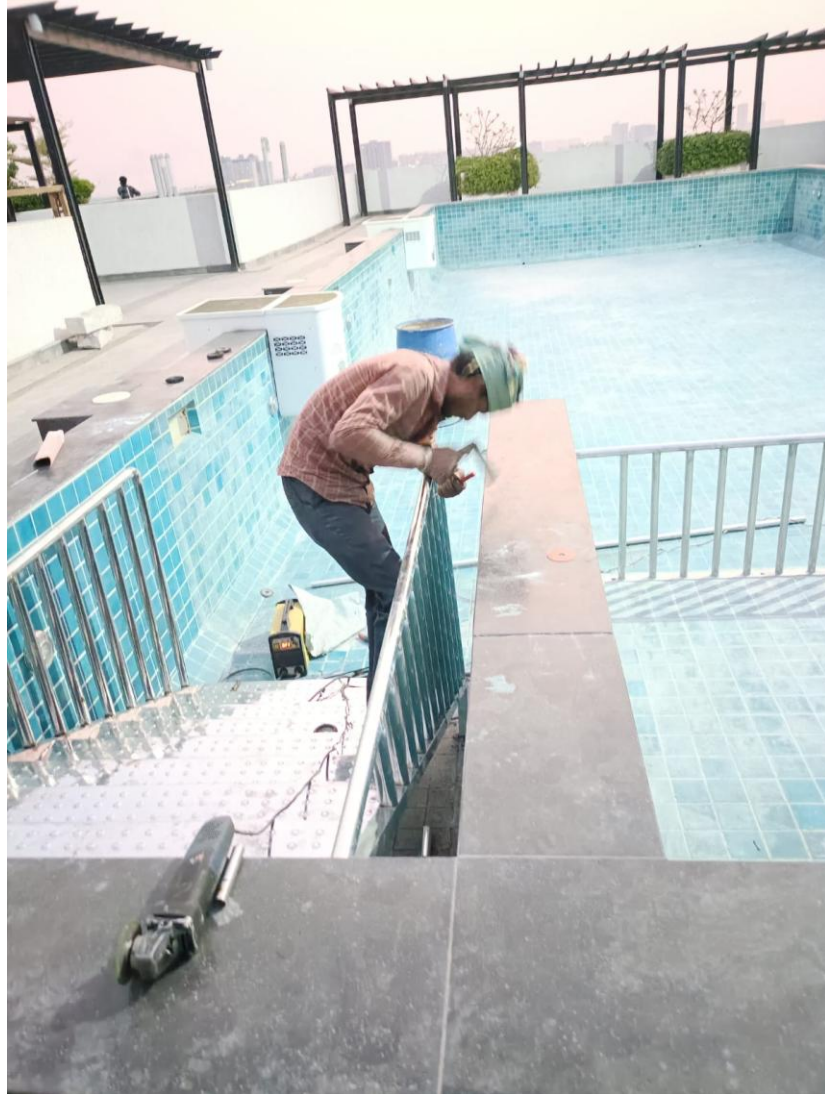
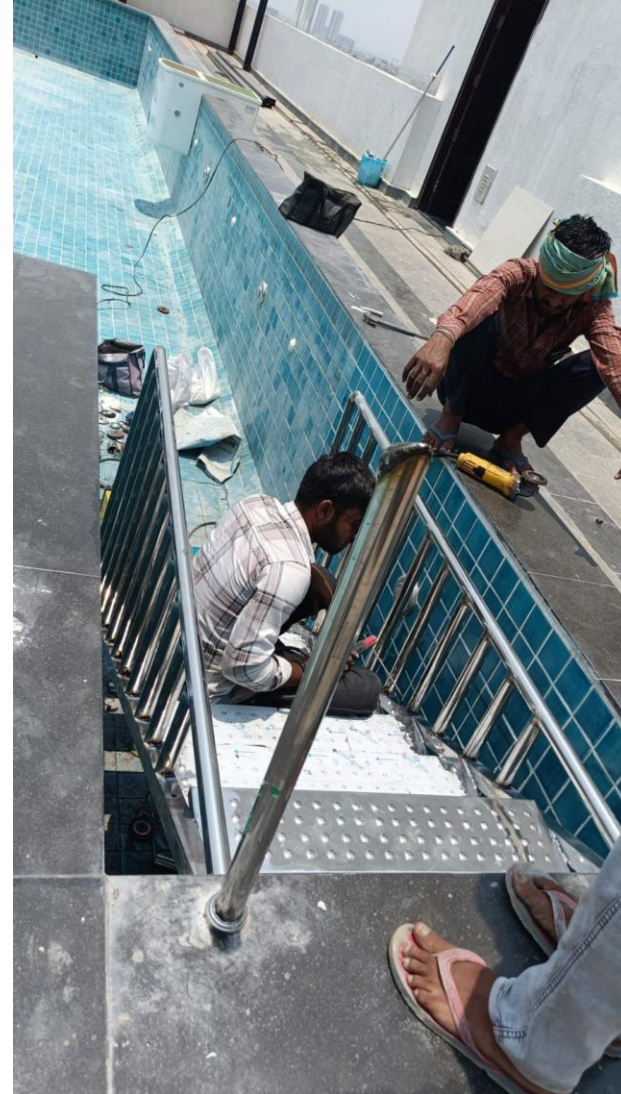
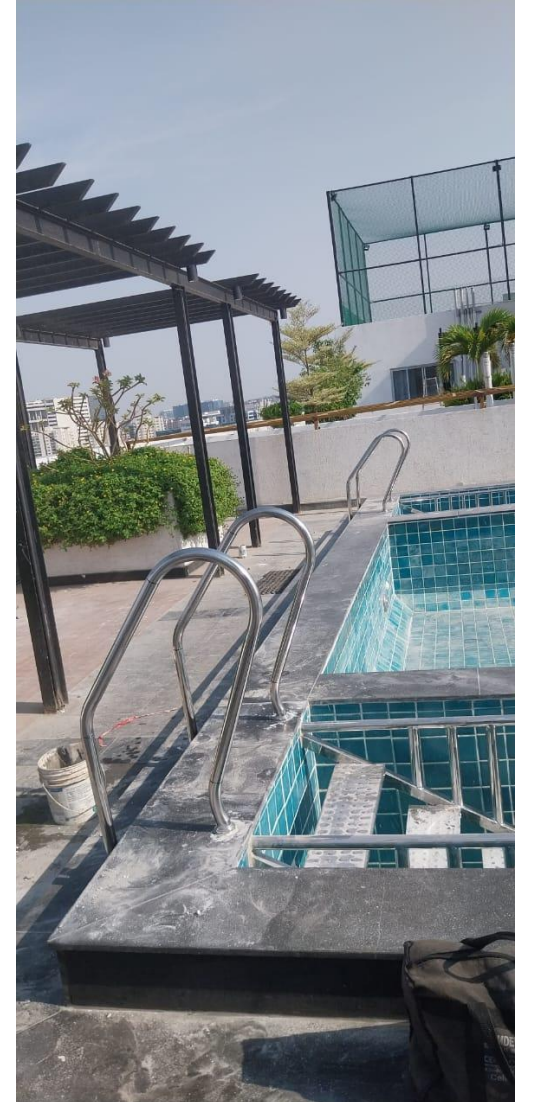
Installation of New Steel Ladder both the sides
